Failure Analysis of Landing Gear Material

Asmadi Lubay¹, Reny Afriany^{1}, Bahrul Ilmi¹, Yeny Pusvyta¹*

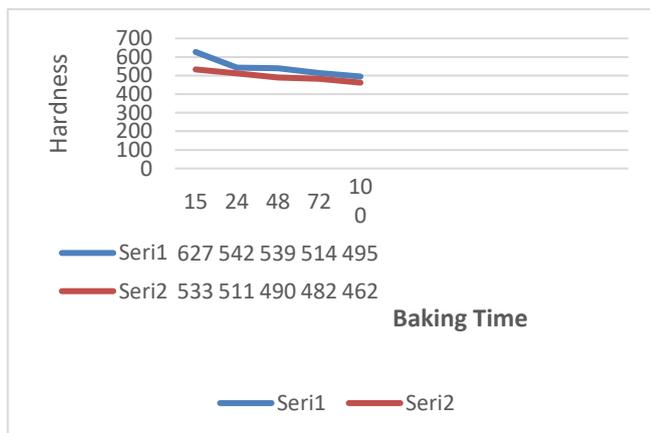
Figure 4. Hardness vs Baking Time

The effect of hydrogen embrittlement in steel is that the ductility of the steel is reduced. However, it can be restored by the baking process. The hardness test data shows that the longer the baking time (for the same temperature) and the higher the baking temperature (for the same time), the hardness of the material will decrease, which means that the brittleness of the material decreases, which also means that material damage (due to internal hydrogen) will occur over a longer period of time. The decrease in hardness as the baking temperature gets higher, leads to a limitation of the baking temperature used, this is because even though the

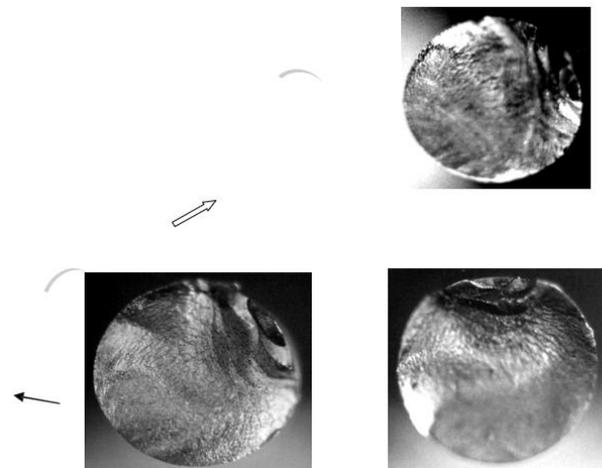
Figure 5. Broken Surface of Test Item

Macrofractography observations show that the fracture is brittle as indicated by the flat shape of the fracture structure. The brittle fracture is caused by internal hydrogen entering the material during the coating process with Cd. In Figure 5 it can be seen that the crack starts from the arrow which then increases in size and propagates to the outside of the grain surface. The final fracture occurs because the

remaining cross section is no longer able to withstand further load.

Generally, the initial crack starts from the notch area where there is an imperfect cadmium layer. The result of the cadmium layer is uneven thickness, especially in the notch area. The occurrence of the initial crack starts from the notch area where there are surface defects in the form of micro cracks. In the area of micro cracks, there are imperfections in the Cd layer. In addition, there is a concentration of stress that can cause strain localisation so that it can lead to the onset of an initial crack. In steels containing internal hydrogen, fracture can occur at stresses much lower than the tensile stress.

From the results of microfractography observations, it can be seen that the shape of the fracture that occurs is intergranular where this fracture model occurs in all test specimens. This fracture is caused by the load in endurance testing with a very slow strain rate / static loading. Most of the grains show an cleavage shape (only a few are dimple shape), this indicates that the fracture is brittle.

- 1) To prevent damage due to hydrogen embrittlement, the material must be baked for 48 hours at a temperature of 2500 C.
- 2) Embrittlement of material by hydrogen is obtained from electroplating baths that use conventional cyanide coupled with brighteners.
- 3) Embrittlement by hydrogen is also due to the presence of elemental sulphur which is cathodic poisons that segregate to the grain boundaries.
- 4) Hardness will decrease if the baking temperature is higher and the baking time is longer.
