## Fan Blade Balancing Process on CFM56-5B Engine Airbus A320 using the Trim Balance Method

Dimas Augie Nugroho<sup>1</sup>, Ni Ketut Caturwati<sup>1\*</sup>

<sup>1</sup>Departement of Mechanical Engineering, Universitas Sultan Ageng Tirtayasa, Cilegon, 42435, Indonesia

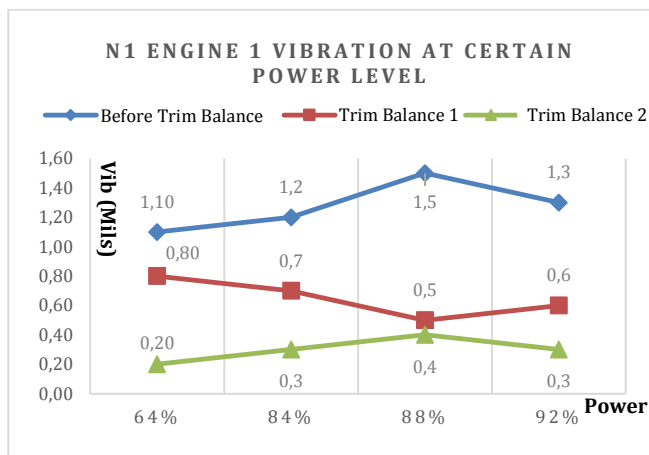
Figure 5. N1 Engine 1 Vibration Graphic

Figures 5. and 6. show that the *Trim balance process* will reduce the amount of vibration that occurs in the engine, but not significantly. For engines that initially have a large vibration value, the trim balance process is needed more than once. In this case, the Airbus A320 aircraft needed 2 processes to comply with the feasibility parameter of the magnitude of vibration in the engine, which is 1.0 mils.
