Analysis Of Welding Results On A Pressure Vessel Using Radiography Test Method At PT. DIHI

This research presents the conclusions of the testing conducted at PT. Daekyung Indah Heavy Industry, focusing on the Quality Control process applied to pressure vessels. The Quality Control process involves Non-Destructive Testing (NDT) using the Radiography Test (RT) method. This testing is performed using gamma rays generated by Iridium-192 and applied to a vertical pressure vessel intended to function as a Gas Dehydration Filter. The area under examination is one of the Weld Parts with NC Code on Manhole M1 24 Inch, with SA516-70N material and a thickness of 18 mm, and the entire testing process is conducted with reference to ASME BPVC Section VIII Division I UW-52 as the standard. The test results indicate that out of the 7 areas tested, 5 areas showed indications of defects. Among the 5 areas with defects, there was 1 porosity defect in area A-B and 4 slag inclusion defects in areas B-C, D-E, F-G, and G-A. The repair process required for both types of defects is the removal of the weld groove followed by re-welding until no defects remain in the repaired weld joints.

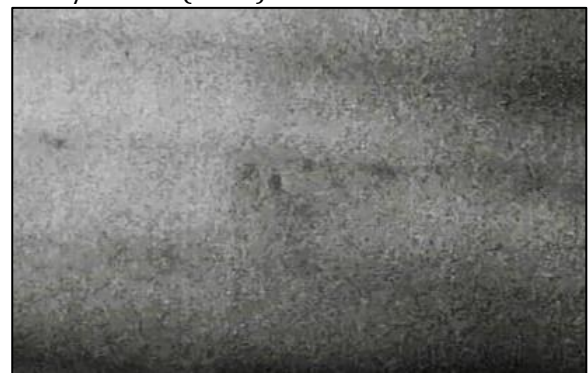
1. M1/24” NC (A - B)

Figure 4. Test Results on M1/24” NC (A - B).

Project	: D2212 / JGC	Type of Material	: SA516 - 70N	
Lokasi	: Cilegon	Thickness	: 18 mm	
Date	: 06 / 07 / 2023	Accept. Code	: ASME VIII	
No. Wo	: 13 - V - 1108 B			
No. Joint	: M1/24" NC			
Area	Type of Defect	Defect Size	Acceptance Criteria	
			Accept	Repair
A - B	Porosity	11 mm	✓	
B - C	Slag Inclusion	27 mm		✓
C - D	-	-	✓	
D - E	Slag Inclusion	18 mm		✓
E - F	-	-	✓	
F - G	Slag Inclusion	20 mm		✓
G - A	Slag Inclusion	75 mm		✓

3. Test results on the pressure vessel revealed defects in 5 out of 7 designated areas, based on radiography testing results, with 1 porosity defect detected in area A - B and 4 slag inclusion defects detected in areas B - C, D - E, F - G, G - A. The repair process required for both defects is the removal of the weld groove followed by re-welding until no defects remain in the repaired weld joints .

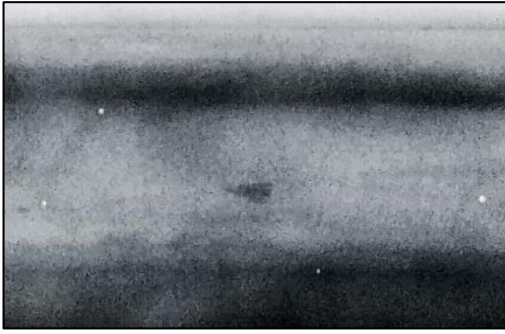
3. M1/24" NC (D - E)

Figure 6. Test Results on M1/24" NC (D - E).
