## **IDENTIFICATION OF INDUCED DRAFT FAN (IDF) DAMAGE IN BOILER WASTE GAS SYSTEM**

**Yasdin<sup>1</sup>, Alimin<sup>1</sup>, Siti Ramasih<sup>1</sup>**

<sup>1</sup>Departemen of Automotive Engineering Education, Faculty of Engineering,  
Universitas Negeri Makassar

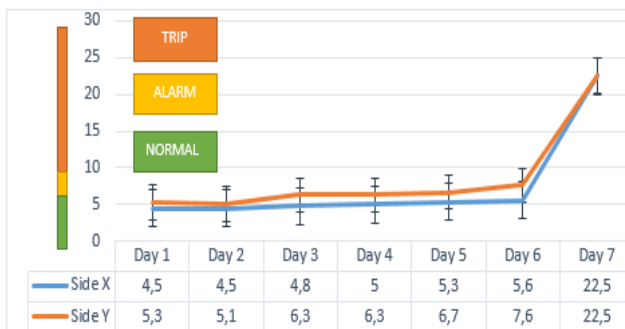
Figure 2. Vibration Indication Parameter Chart

Based on the table and graph of the vibration parameters above in induced draft fan 2B within 1 week from day 1 to day 6 of high vibration for side X which is an average of 4.9 mm/s and side Y height of average vibration reaching 6.2 mm/s, the indication of vibration at this altitude indicates an alarm indication, on day 6 on the Y side the vibration is on the indication of trip, but the operator based on the results of the daily meeting has not decided to stop the unit. While on the 7th day the unit is stopped or trip, because it experiences an increase in vibration reaching 22.5 mm/s. Based on the control instrument equipment indicating vibration indication if the height of vibration side X or Y side is, 65.6 mm/s then the condition is stated in an alarm state, whereas if at an altitude of  $\geq 7.1$  mm/s then the unit trip.

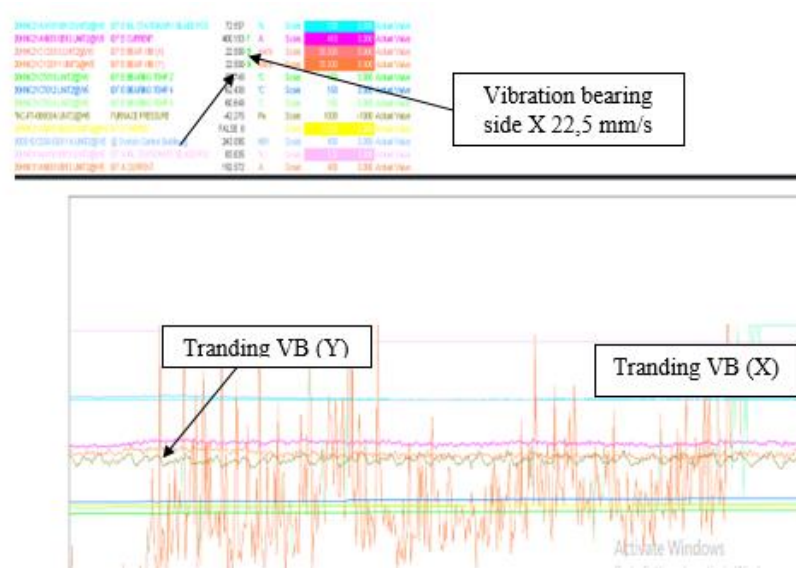
Figure 3. Tranding Indicator for Vibration

Then based on the Distributed Control System (DCS) data above the IDF 2B vibration on the 7th day of the X side which is shown by the brick red color graph and the Y side shown by the Pict color graph, the increase is very significant with a height of 22.5 mm / s which almost reaches the maximum limit of 30 mm / s. In addition to the breaking signal indication (Signal Bad), the Ampere rises for 2 seconds from 213 A to 400 A, the Furnace Pressure rises to 42 Pa which is shown by the brown chart, it should be at -30 Pa. So, IDF 2B was stopped from the Central Control Room (CCR) because it was based on information from local high vibration and broken damper isolation.

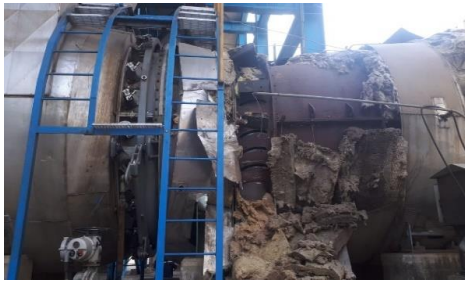
Figure 5. Damaged Cover Insulation

Damaged insulation cover may be due to the release of static basic blade and high vibration of 22.5 mm/s for 45 minutes causing main bearing to exit its position.

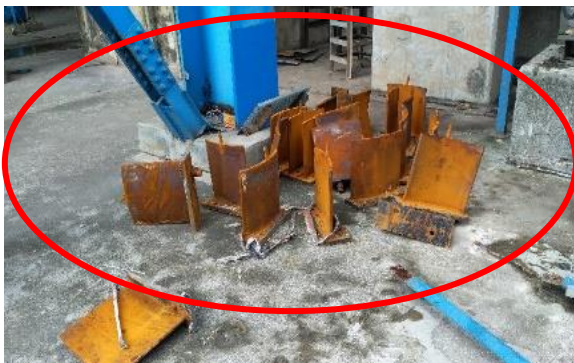
Figure 6. Damage to Static Blade

Static blade detached from its position, the fixing bolt was cut off and part of the casing plate was damaged due to thinness which was 15 mm to 5 mm.

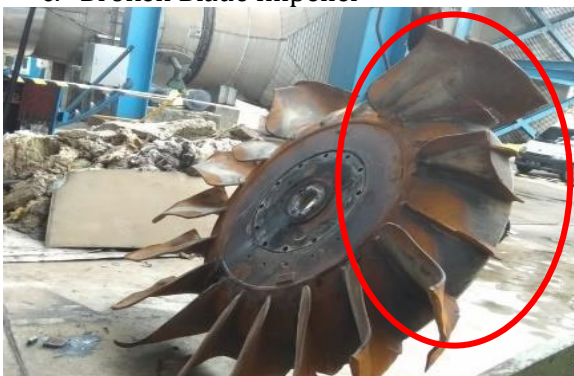
Figure 7. Damage to the Blade Impeller

The condition of the blade impeller is completely bent and broken 4 pieces, bent and broken due to changes in the position of the bearing so that the blade touches the casing, so that the trigger of vibration increase to 22.5 mm/s.

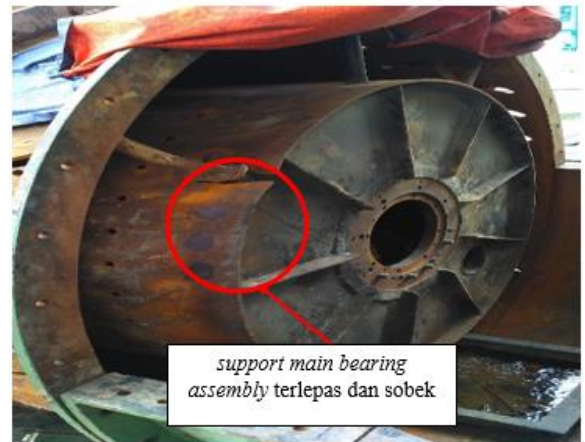
Figure 8. Damage to the Main Bearing Assembly Support

The support conditions for the main bearing assembly are detached and torn on the base plate, so the possibility of causing the main bearing housing to drop or out of position causes the impeller blade to touch the casing and bend.

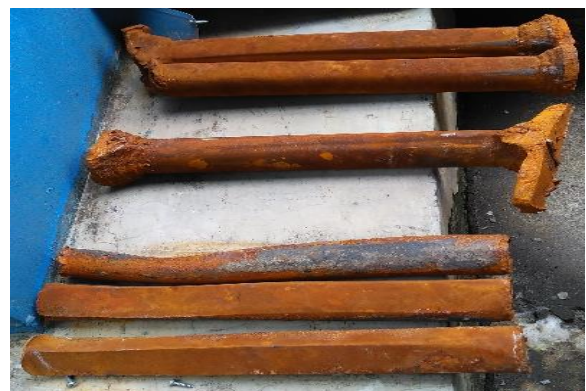
Figure 9. Damage to the Support Coupling Bolt

The condition of the bolt support coupling is cut off from its position, possibly due to the shaft and coupling down, support is bent and dragged by the impeller blade so that it is cut off.
