Analysis Of Welding Results On A Pressure Vessel Using Radiography Test Method At PT. DIHI

This research presents the conclusions of the testing conducted at PT. Daekyung Indah Heavy Industry, focusing on the Quality Control process applied to pressure vessels. The Quality Control process involves Non-Destructive Testing (NDT) using the Radiography Test (RT) method. This testing is performed using gamma rays generated by Iridium-192 and applied to a vertical pressure vessel intended to function as a Gas Dehydration Filter. The area under examination is one of the Weld Parts with NC Code on Manhole M1 24 Inch, with SA516-70N material and a thickness of 18 mm, and the entire testing process is conducted with reference to ASME BPVC Section VIII Division I UW-52 as the standard. The test results indicate that out of the 7 areas tested, 5 areas showed indications of defects. Among the 5 areas with defects, there was 1 porosity defect in area A-B and 4 slag inclusion defects in areas B-C, D-E, F-G, and G-A. The repair process required for both types of defects is the removal of the weld groove followed by re-welding until no defects remain in the repaired weld joints.

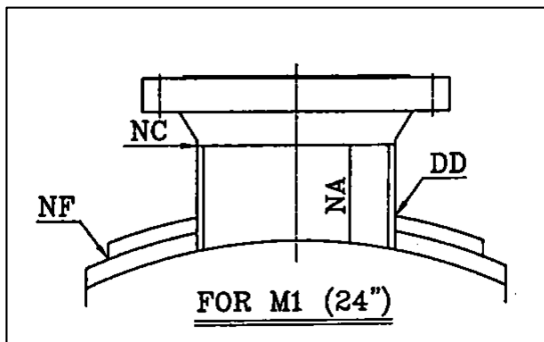
Figure 3. Weld Part Manhole M1 24”.

The inspection process is conducted on one of the manholes located on the pressure vessel. This testing focuses on the welding groove with the code NC, which refers to the welding that joins the flange with the shell manhole. The welding performed at this point utilizes the GTSM welding type, with a material thickness of 18 mm for the shell manhole, and the material type used is SA516-70N. For further clarity, please refer to the image below.
